**National Transportation Safety Board
Operations/Human Factors Group Factual
Technical Review Version**

Accident No.: DCA-10-MM-025

Description: Towing Vessel *Caribbean Sea*, and barge *The Resource*, allision with the Amphibious Passenger Vehicle (APV), *DUKW 34*

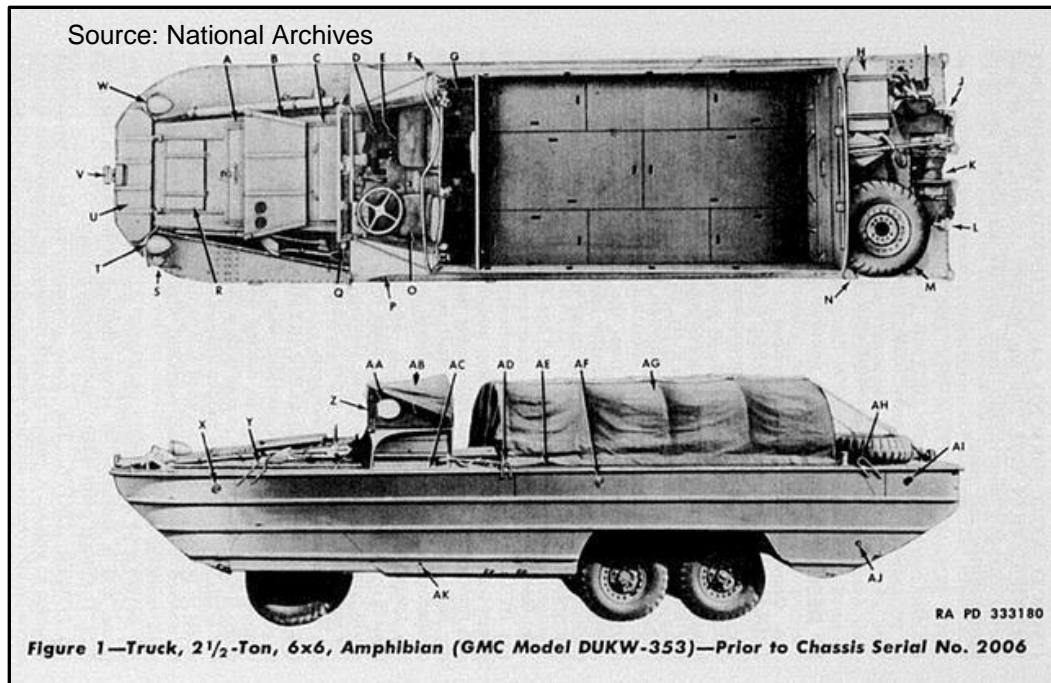
Figure 1 - Military version of the DUKW
